**Somerset  
Council**

# **Flood Investigation Report**

*Section 19 Flood and Water  
Management Act 2010*

**Pitt Valley**

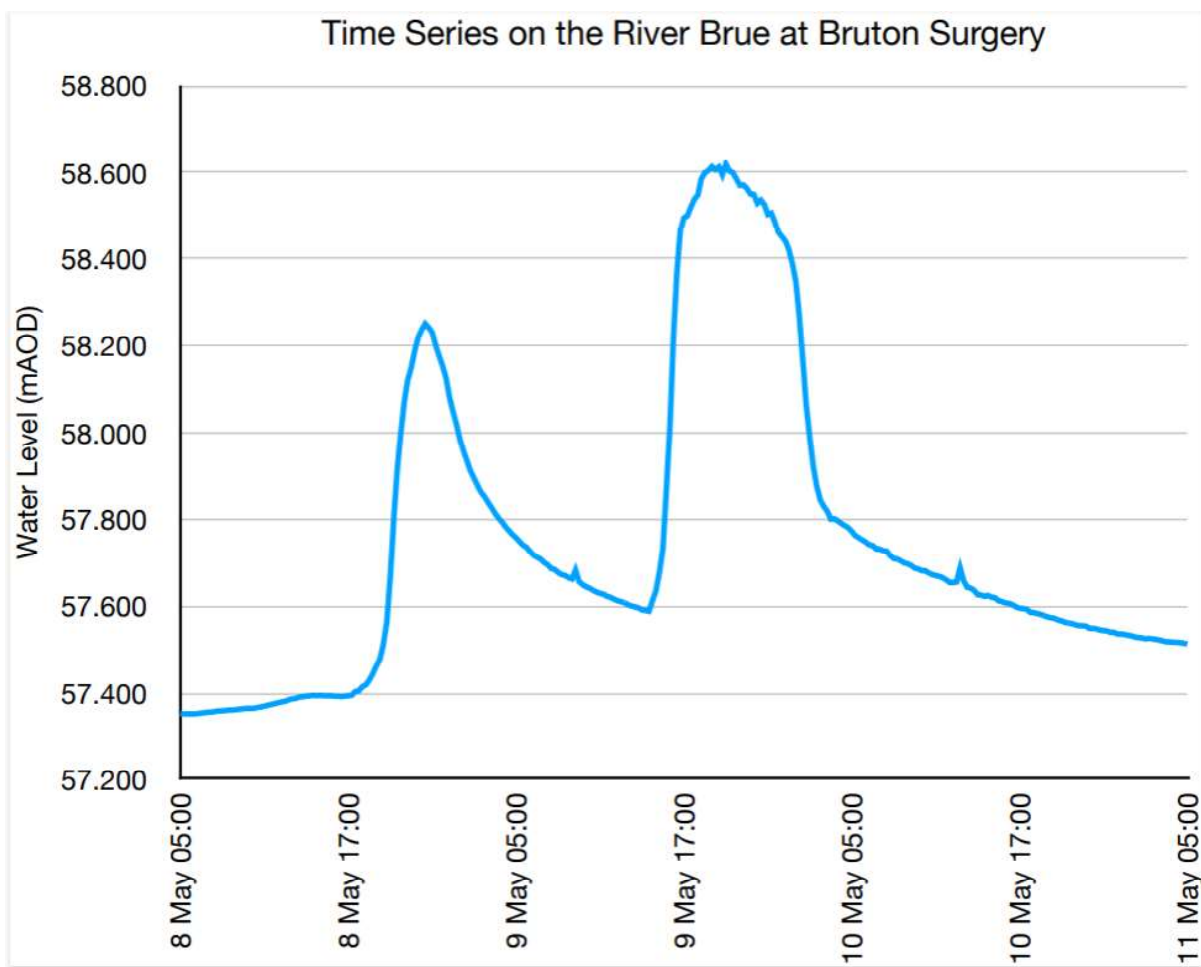
Figure 5 Environment Agency rainfall data for River Brue at Bruton Surgery on 9th May 2023

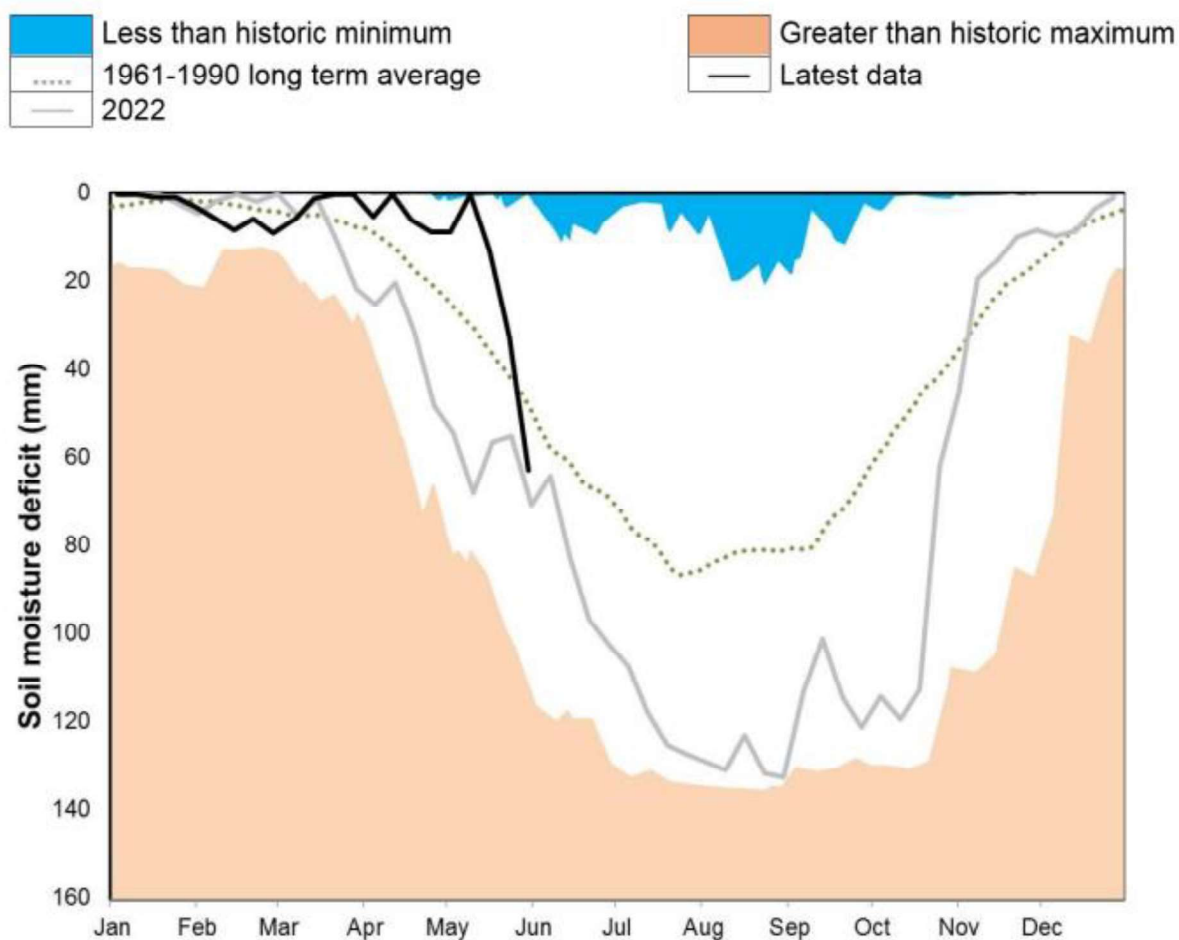
“Soil moisture deficit decreased early in May before increasing by around 60mm in the last few weeks of the month. At the end of the month the deficit was higher than the LTA but similar to May last year.”

Figure 6 Latest soil moisture deficit compared to previous year, maximum, minimum, and 1961 to 1990 long term average. Weekly MORECS data for real land use (Met Office) [\[SP1\]](#) [\[JM2\]](#) [\[AF3\]](#) Source: Met Office. Crown copyright, 2023). All rights reserved. Environment Agency, 100024198, 2023)

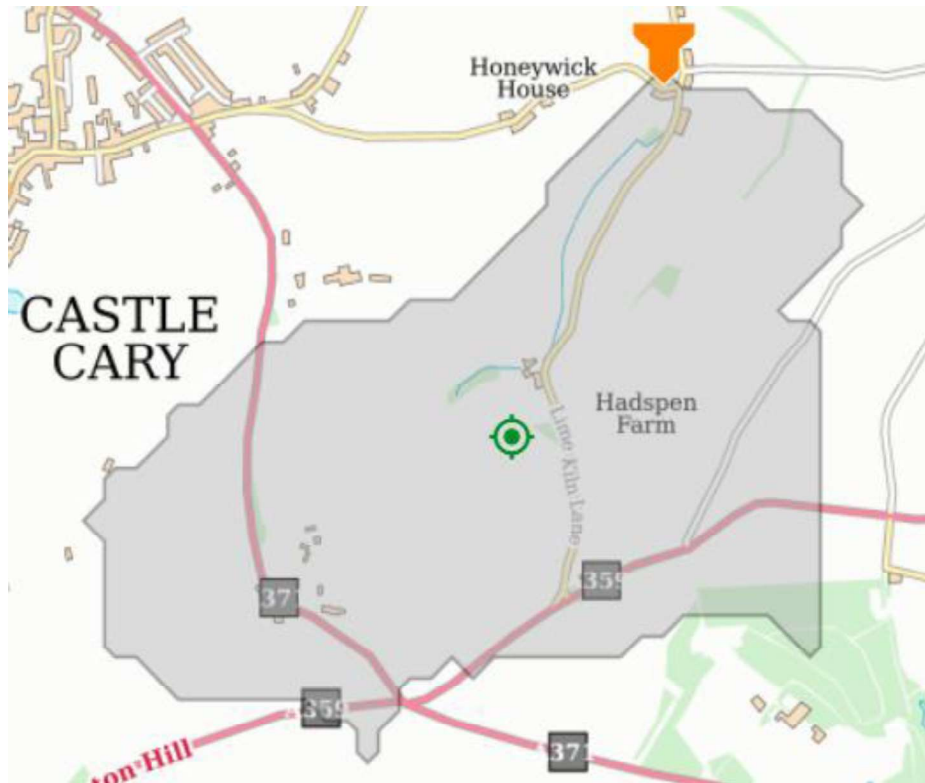
Figure 13 Flood Estimating Handbook: catchment boundary for Hadspen

According to the flood Estimating Handbook, the catchment drainage area for site is 1.7 km<sup>2</sup>, based on National Grid Reference ST 65650 32600. (Derived using an Integrated Hydrology Digital Terrain Model (GDTM) developed at UKCEH Wallingford).

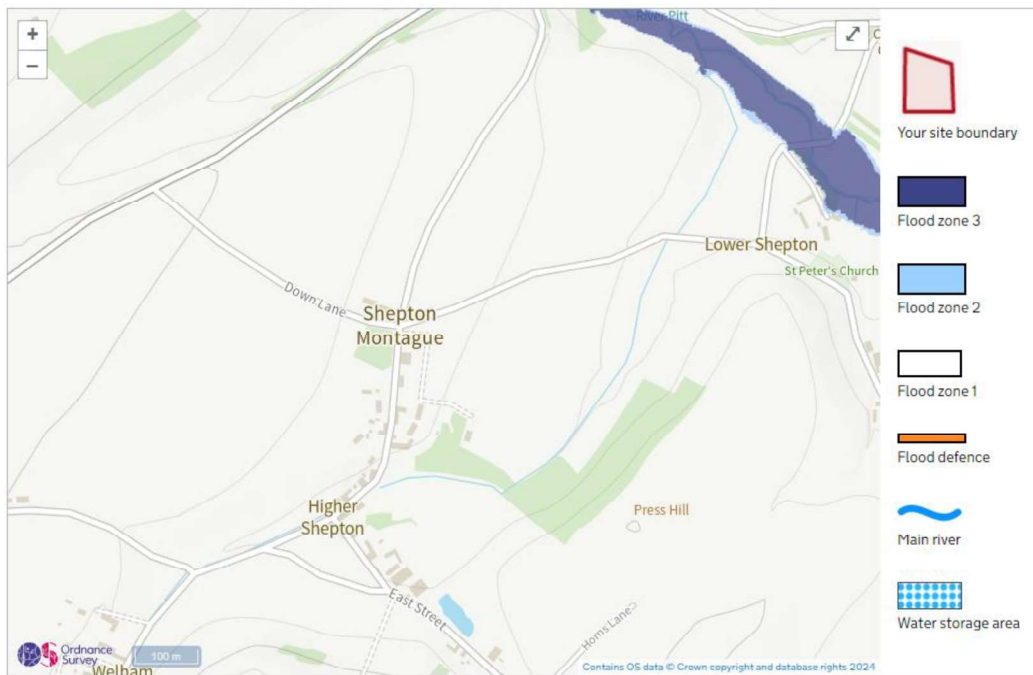
Figure 14 Map showing flood risk to Shepton Montague and surrounding area. Flood map for planning – gov.uk – OS data Crown Copyright and database rights 2024

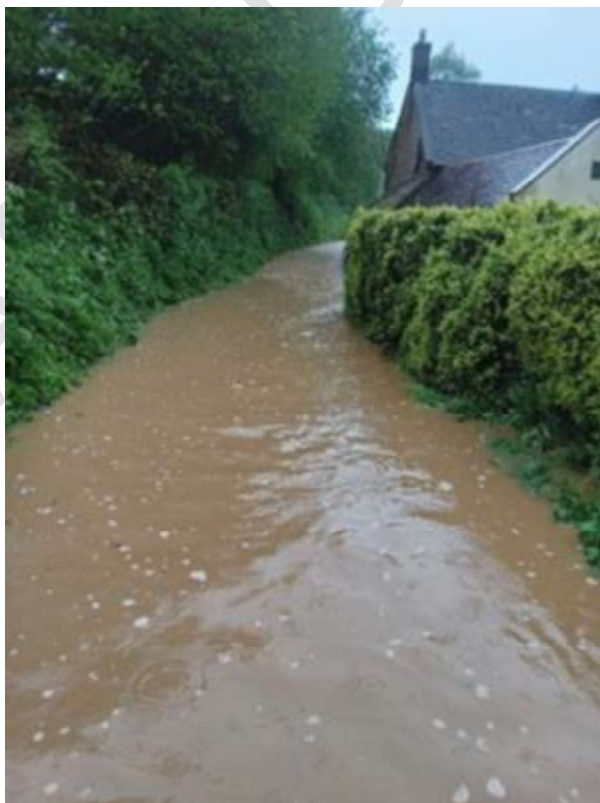
Figure 26 Image showing flow of water down Line Kiln Rd past Priddles Hill Farm on 9th May 2023

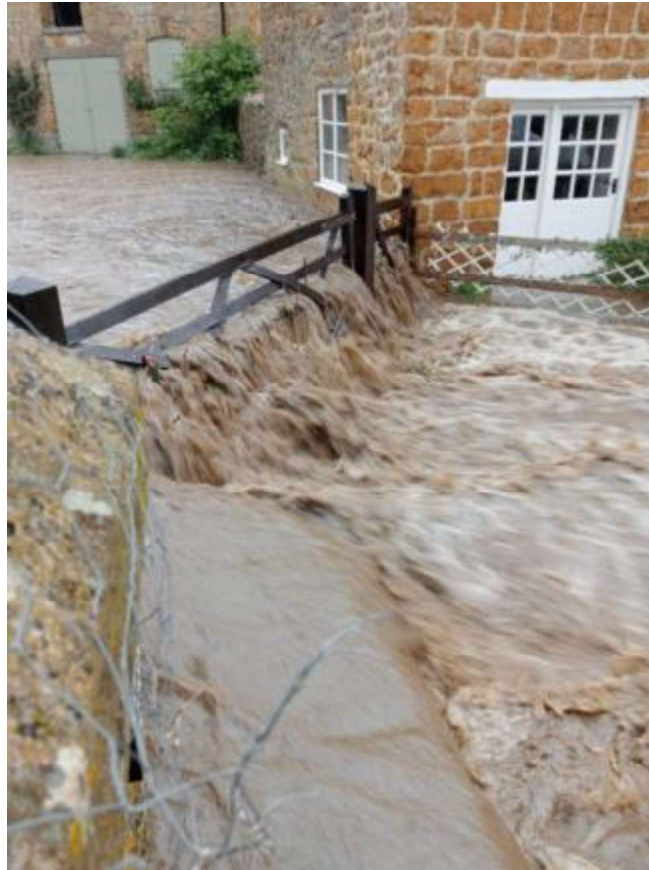
*Figure 27 Image showing flow of water past Ring House from Hadspen Farm on 9th May 2023*

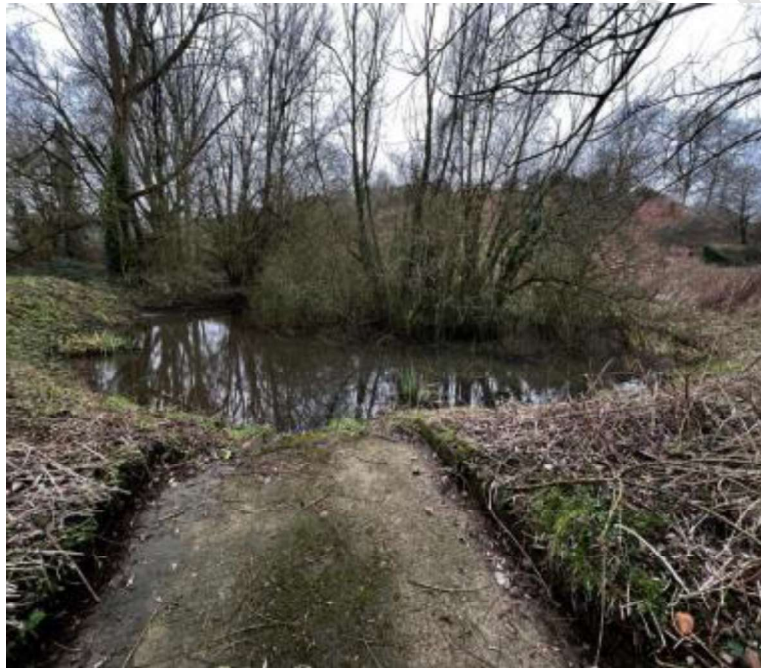
- Maize Run-off: Certain fields within Hadspen experience exacerbated run-off, possibly due to maize cultivation and the direction of water flow.
- Pig farming on the steep valley leaving top soil bare
- Drainage Pond Discharge: The discharge from the village's drainage ponds is not consistently managed.

*Figure 28 Flood relief pond opposite Hadspen Valley Farm, constructed 1984*

<b>Hadspen</b>	
LLFA	Investigate maintenance reliabilities for the flood relief pond (dredging)  Investigate improvements and development of current attenuation pond
LLFA	Investigate impact development from last 10 years has had on flooding.
<b>Shepton Montague</b>	
LLFA, SRA	Natural Flood Management:  Investigate opportunities to hold water beneath Lower Shepton (such as using a leaky dam)

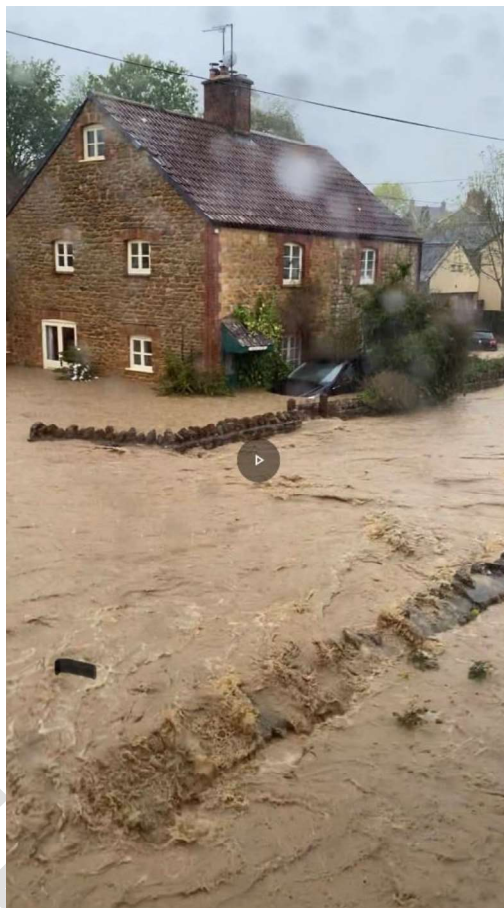
*Figure 31 Capture from a video of Dick's Cottage flooding on 9th May 2023*
